**REPORT TO BOARD OF DIRECTORS OF
GENERAL MOTORS COMPANY
REGARDING IGNITION SWITCH RECALLS**

May 29, 2014

Anton R. Valukas

J E N N E R & B L O C K

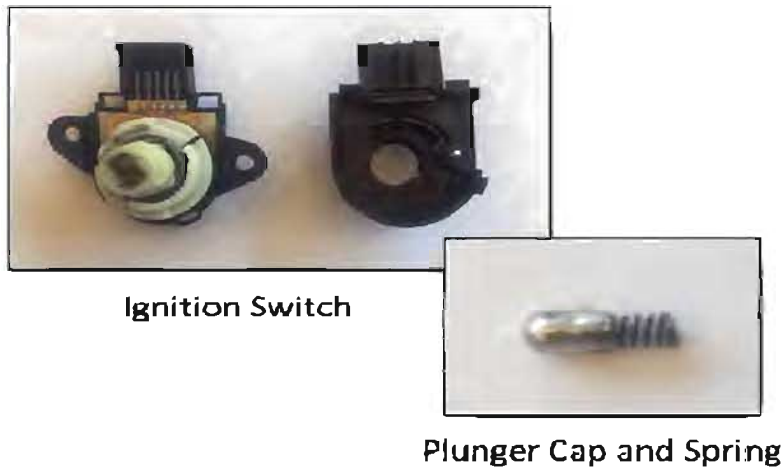
Components within the Ignition Switch control the amount of effort required to turn the switch from one position to another. A plunger cap and coiled spring inside the Ignition Switch sit in a small groove called a “detent,” which holds the switch in the position to which the driver turns the key: Off, Run, Accessory, or Crank. The driver rotates the key by applying a certain amount of torque to overcome the detent, thereby rotating the switch out of one position and into another. One method to increase the effort required to rotate the Ignition Switch from one position to another is to use a longer and more tightly coiled spring.

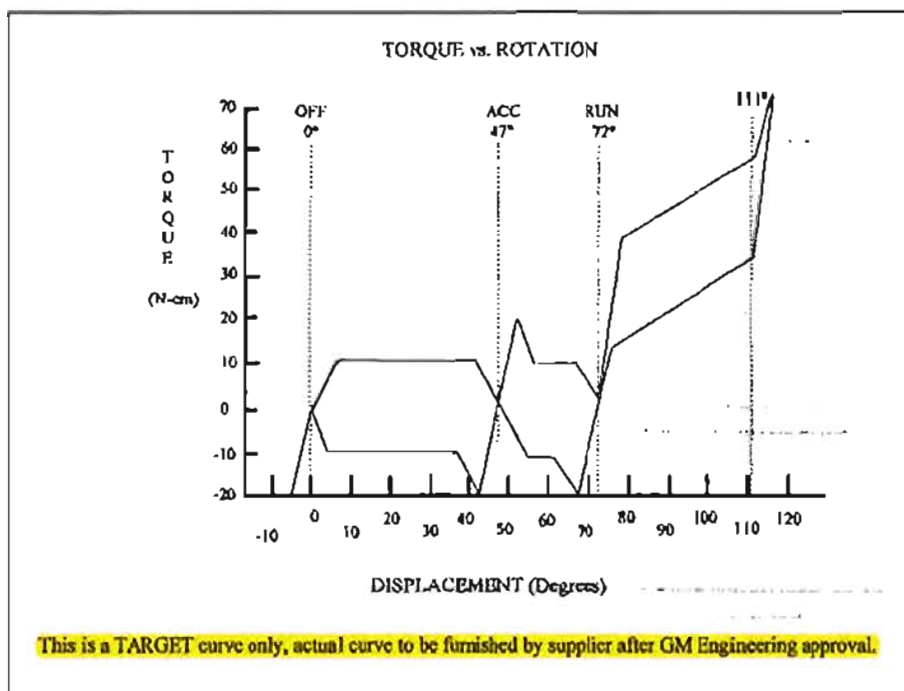
cm”) as the torque needed to turn the ignition from Run to Accessory.¹¹⁰ As noted below, the target curve indicated that the “actual curve [was] to be furnished by [the] supplier after GM Engineering approval.”¹¹¹

Section 3.2.2.3 described the desired feel of the switch – “smooth, with clearly defined detents” – and also provided that “[f]inal switch tactile feel is subject to GM Engineering approval.”¹¹² The Specification was revised in 1998 and 1999, without changes to the parameters for the torque required to rotate from Run to Accessory.¹¹³

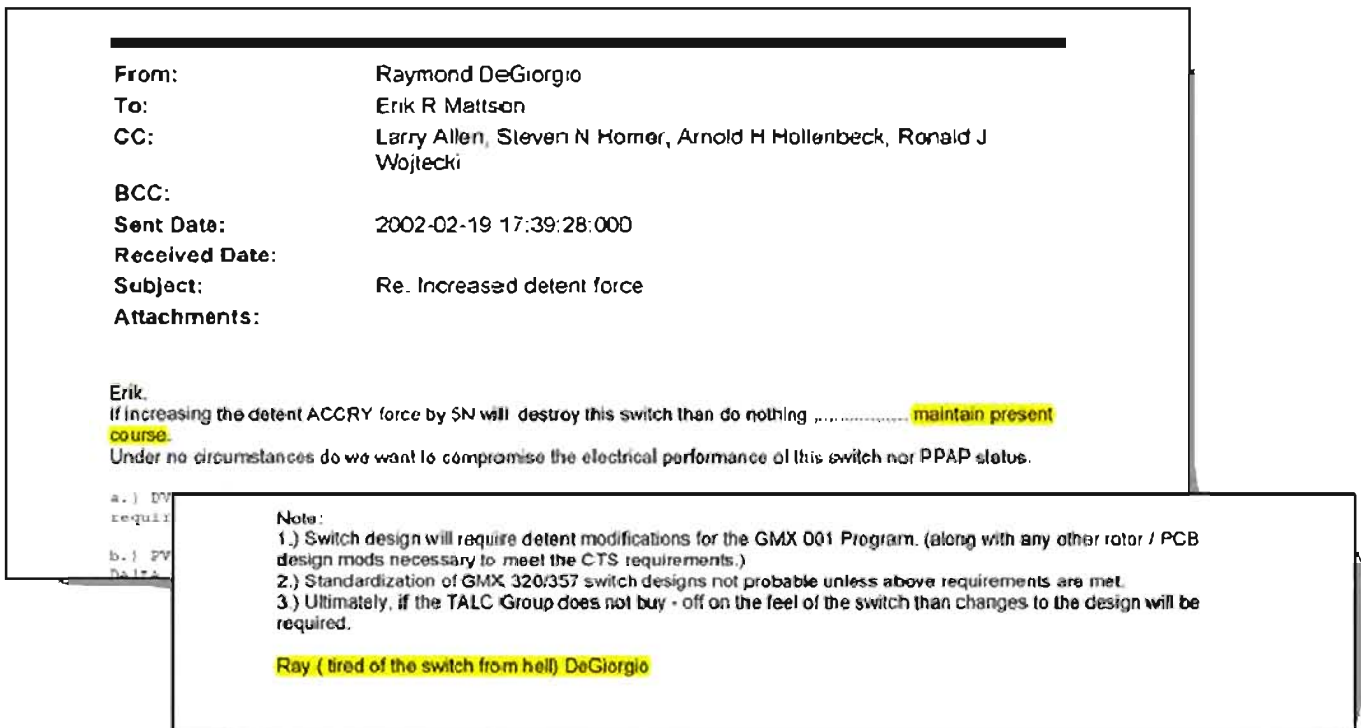
Program.”¹⁷⁰ Thus, despite knowing the torque values were well below the Specification, DeGiorgio instructed Delphi to take no action to increase the rotational torque out of concern that changing the detent would compromise the electrical performance of the switch; at the same time, he notified Delphi that detent modifications would be required to increase torque in accordance with the Specification before the switch (currently planned for the Ion) could be used in the Cobalt, scheduled for launch in 2004.¹⁷¹ DeGiorgio signed his response, “Ray (tired of the switch from hell) DeGiorgio.”¹⁷²

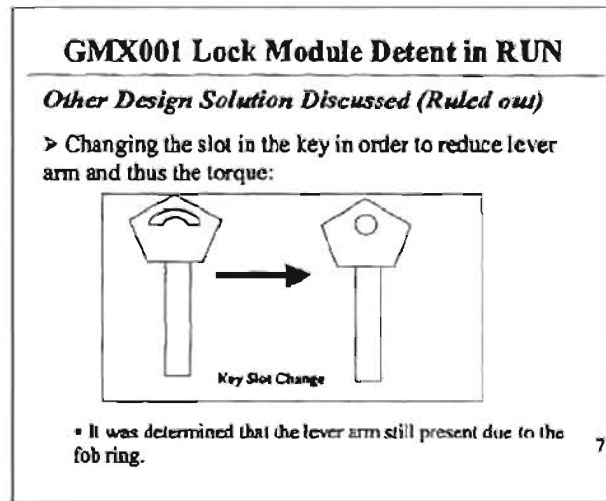
The presentation also included some “Ruled Out” solutions, including changing the design of the key head from a slot to a hole – a solution GM personnel ultimately pursued. With a slot design, the key ring could move up and down in the slot. If the key ring contained extra weight, that movement could exert torque on the Ignition Switch and, combined with other circumstances, move it from Run to Accessory. Keeping the key ring in the center of the key (through a hole design) would prevent such movements.²⁶¹ The estimated cost to make the key change was \$70,000 for tooling for a new key head, \$400,000 to modify production assembly equipment, and a piece price increase of \$0.50 per vehicle.²⁶²

The presentation to the CPIT also described a “Sure Solution” to fix the problem: change the location of the Ignition Switch on the steering column from a low-mount to a higher mount.²⁶³ According to David Trush, the Lead Design Engineer on the ignition cylinder, the

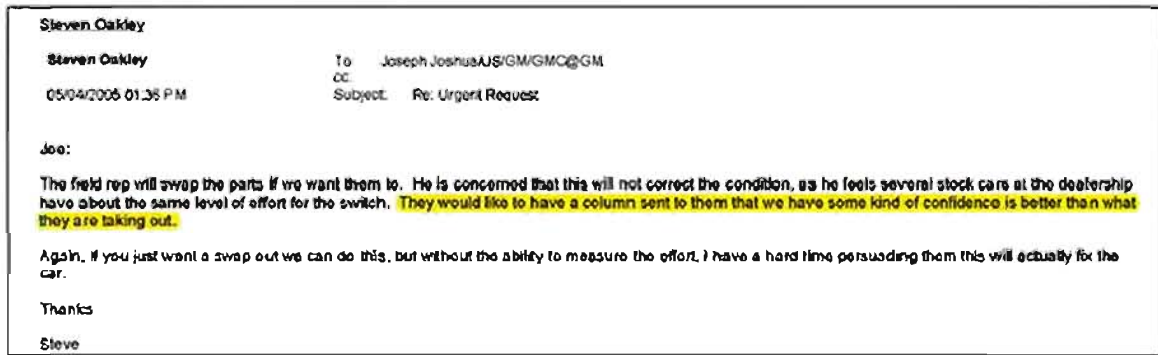
The field rep will swap the parts if we want them to. He is concerned that this will not correct the condition, as he feels several stock cars at the dealership have about the same level of effort for the switch. They would like to have a column sent to them that we have some kind of confidence is better than what they are taking out. Again, if you just want a swap out we can do this, but without the ability to measure the effort, I have a hard time persuading them this will actually fix the car.³¹¹

DeGiorgio was one of the GM personnel who received this e-mail chain, which effectively stated that the customer’s car, as well as others at the dealership, had Ignition Switches with insufficient torque and, at least in the customer’s situation, appeared to cause the car to shut off while driving.³¹² For his part, DeGiorgio claims not to recall the e-mail exchange. DeGiorgio also claims that at this time he still had not received any complaints about the Ignition Switch in the Ion, which had the same Ignition Switch and had been in production since MY

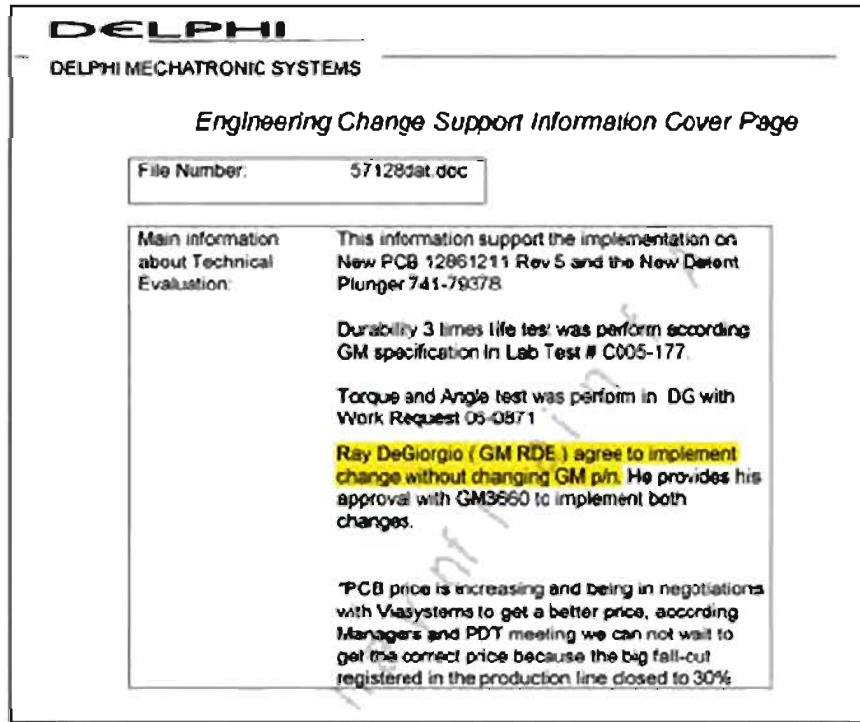
Although the design of the Ignition Switch changed, the part number remained the same. An internal Delphi document dated May 27, 2006, expressly stated that “Ray [sic] DeGiorgio ... agree[d] to implement change without changing GM

p/n. He provides his approval.”⁴¹¹ As Mary Barra has explained, it was “Engineering 101” that, given the significance of the change to the ignition switch, the part number should have been changed.⁴¹² But DeGiorgio did not change it.

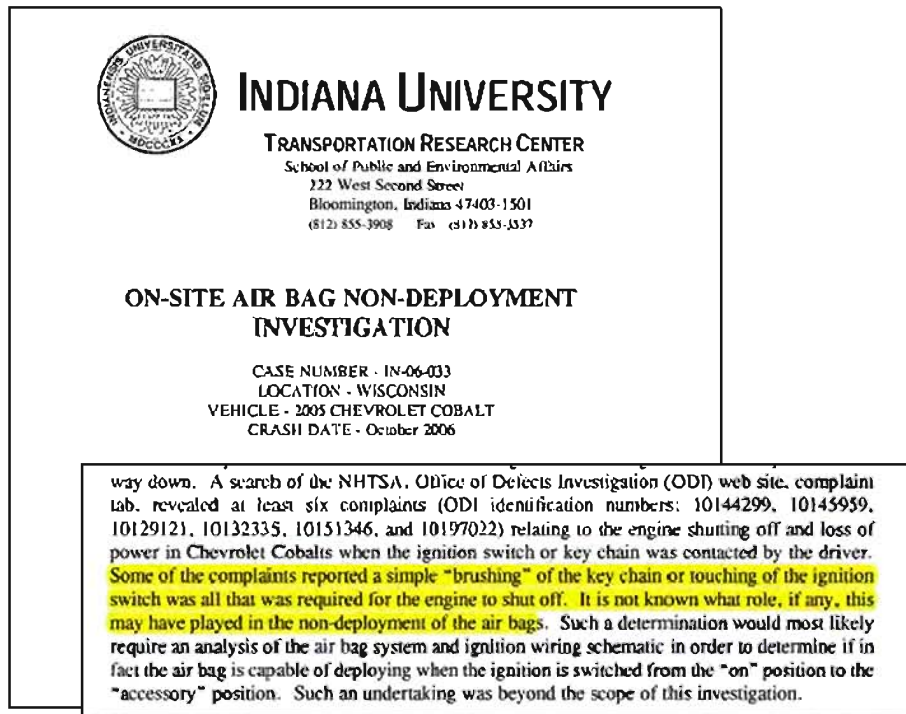
Some of the complaints reported a simple “brushing” of the key chain or touching of the ignition switch was all that was required for the engine to shut off.⁵¹⁹ The researchers concluded:

It is not known what role, if any, this may have played in the non-deployment of the air bags. Such a determination would most likely require an analysis of the air bag system and ignition wiring schematic in order to determine if in fact the air bag is capable of deploying when the ignition is switched from the ‘on’ position to the ‘accessory’ position.⁵²⁰

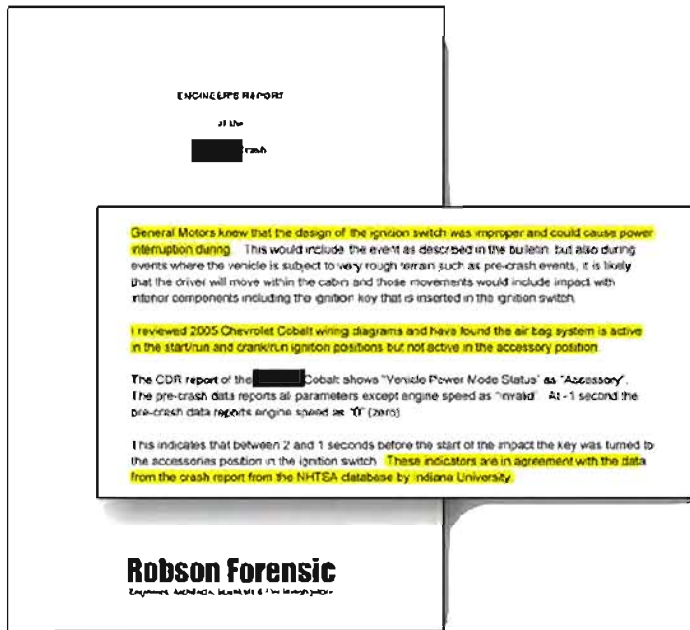
Thus, Shipp concluded: "General Motors' improper design resulted in a vehicle that was defective in a manner that caused the airbag to not deploy in a crash that General Motors has determined should have had an airbag deployment."⁸³¹
